AFWAL-TR-87-4001

FAILURE ANALYSIS OF COMPOSITE STRUCTURE MATERIALS

May 1987

Final Report for Period of 1 October 1985 to 31 August 1986

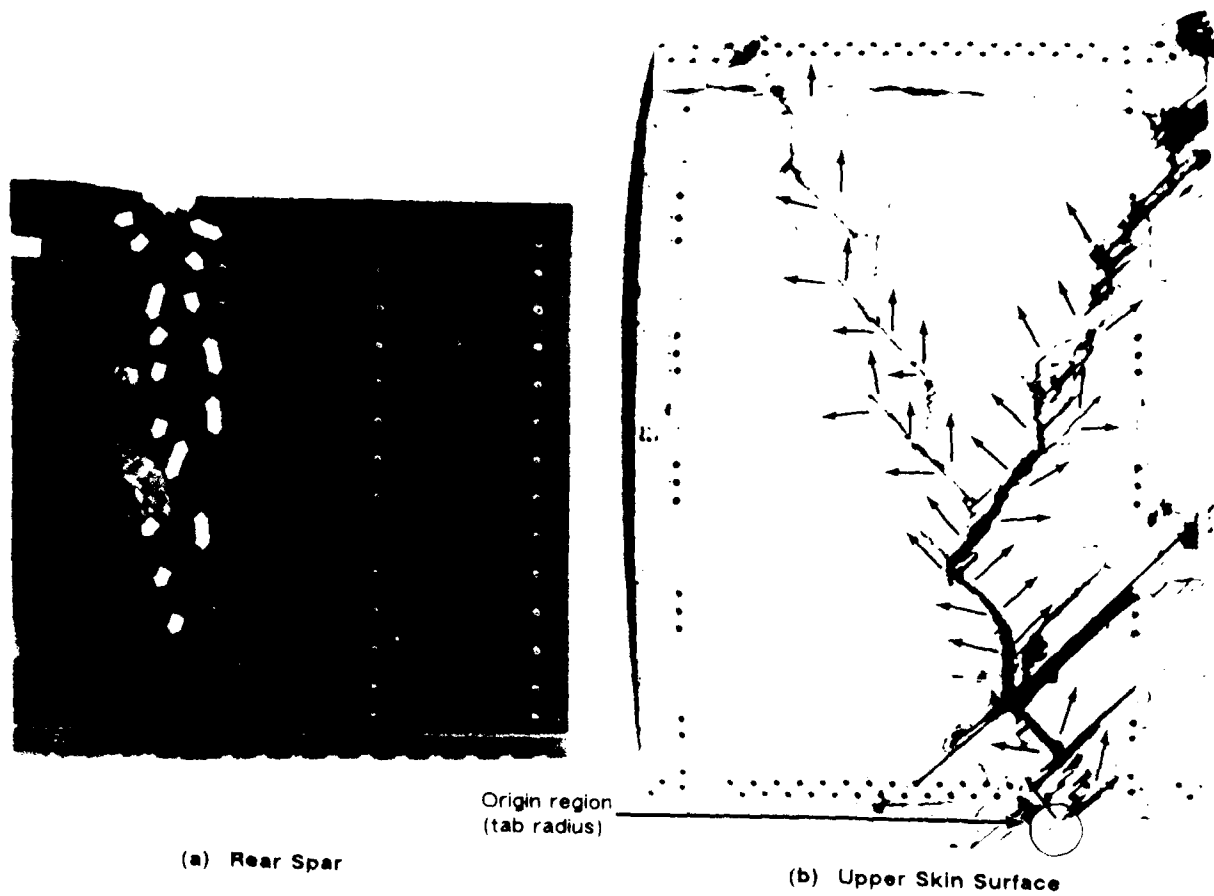
Figure 97. JVX Wing Test Box Crack Mapping Results

At this point the question of the sequence of failure between the upper skin and the rear spar was asked. Experience with fracture analysis of large composite structures indicated that smaller, well defined origin regions tend to initiate at lower overall strain levels at locations such as notches or holes and therefore exhibit less damage at the origin zone. The larger, ill defined origin zones tend to be indicative of overload, or rather, high overall strain fractures (with extensive damage) and are often not
